## 7.6 Integration

## 7.7 Installation

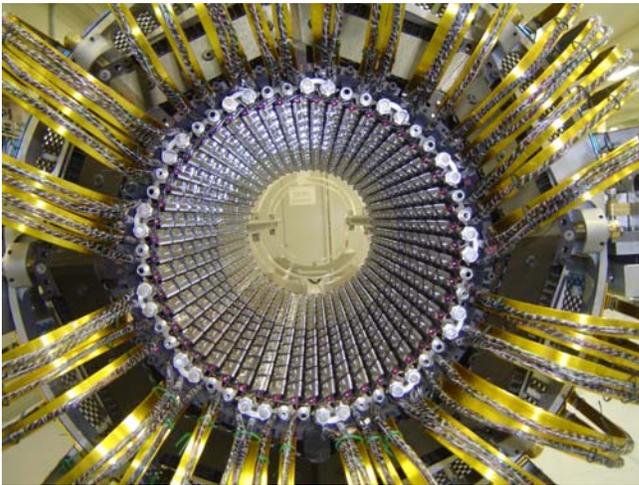
**Fig 7.6.1 (a)** Pixel Layer assembled into global frame and held on the ITT as it appears from looking toward the IP along beam line.

clamped together around the beam pipe after the beam pipe was loaded onto the ITT. Figures 7.6.1 (a) and (b) show, respectively, Layer 2 in the support frame and the full barrel completed with the beam pipe. Electrical services were temporarily folded back onto the frame.

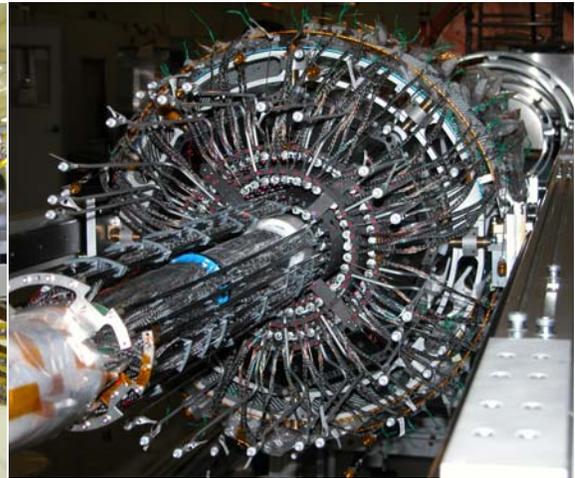
**Fig 7.6.1 (b)** The barrel of the Pixel Detector completed.

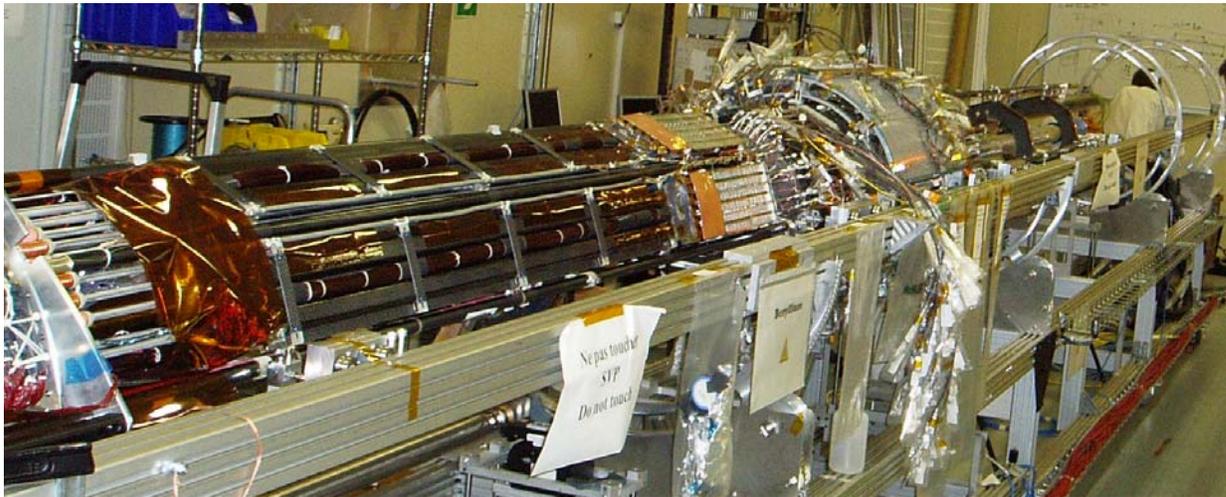
**Fig 7.6.2** Pixel package is loaded with the first SQPs on the ITT.

The four SQP's per side were mounted sequentially on their respective BPSS, and connections to the detector were made immediately after mounting. SQPs were lifted by a small crane and guided by hand onto the BPSS for final connection. Cooling pipes were connected first and tested. Electrical connectors were then plugged into the SQP, dressed, and tested. Figure 7.6.2 shows how the package looked with the first SQP installed. Figure 7.6.3 is a view of the detector connector region (PP0) (see section 7.4) after all the services had been connected.

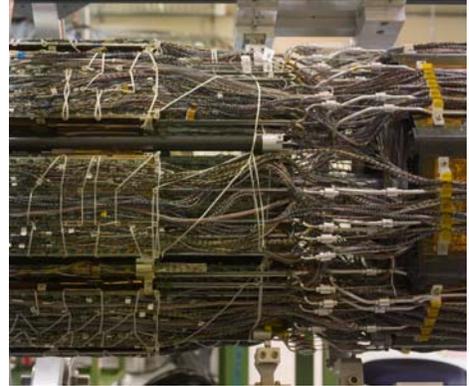
**Fig 7.6.3** View of the services connection at PP0 where the detector is connected to the SQP's

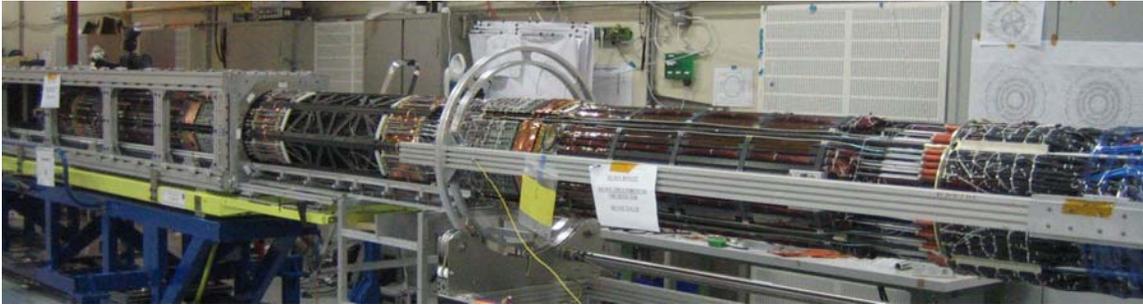
**Fig. 7.7.1** The pixel detector leaves the tool on which has been integrated (ITT on the right) and it enters into the transportation tool [DST on the left]. The blue structure underneath the DST is equipped with pivoting and spring loaded wheels for an easy and shock free transfer outside the building.

The pixel detector inside the DST was transferred from the surface assembly building to a staging area above an access shaft to the ATLAS underground cavern. A combination of a custom-wheeled cart (see the blue structure in Figure 7.7.1) and a portable crane were used. Once in the staging area, the DST was picked up by an overhead crane and slowly lowered into the ATLAS underground hall (Figure 7.7.2a), coming to rest on a platform at the end of the ATLAS ID volume, with the ATLAS endcap-calorimeters retracted to provide sufficient room (Figure 7.7.2b)

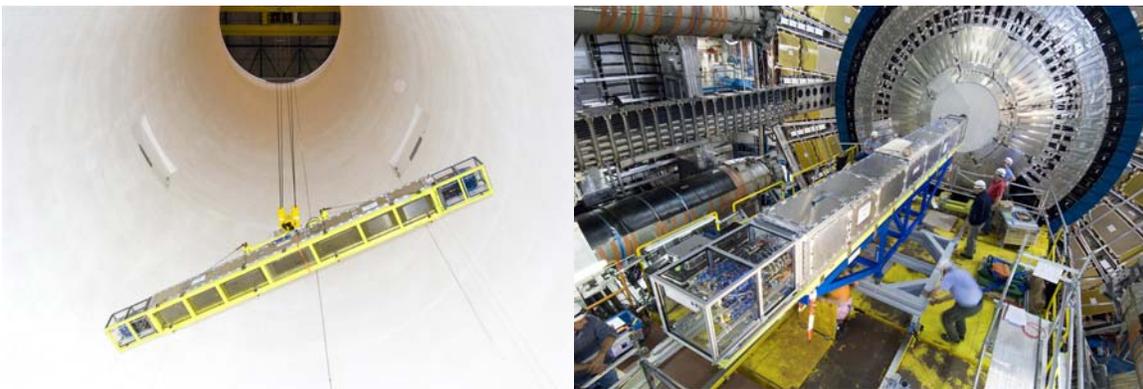
**Fig. 7.7.2** (a) the pixel detector in the Dummy Support Tube (see text) being lowered into the ATLAS underground hall and (b) the Dummy Support Tube and pixel detector on a platform between the Inner Detector area and the endcap calorimeter.

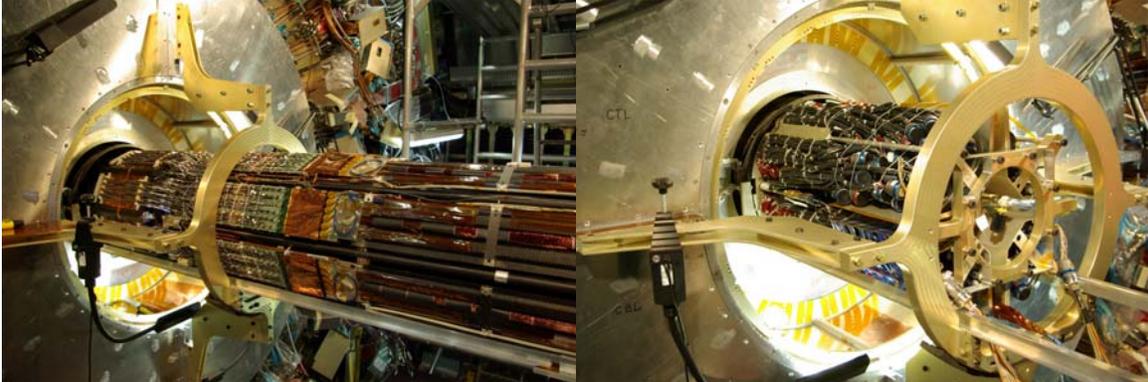
**Fig. 7.7.3** (a) the pixel package during transfer from the DST to the PST showing the region at the end of the inner detector and (b) just before completion of the insertion showing the temporary support of internal services at the end of the package.

The DST was rotated and carefully aligned with the PST, already installed within the Inner Detector. The pixel package was slowly pulled into the PST over about a two day period. The clearance between the pixel package and the PST was very small (by design) in a number of positions along the package, requiring very careful monitoring and small last-minute adjustments. This process is illustrated in Figs. 7.7.3a and 7.7.3b.
